INSTALLATION RESTORATION PROGRAM PRELIMINARY ASSESSMENT

109th TACTICAL AIRLIFT GROUP NEW YORK AIR NATIONAL GUARD SCHENECTADY COUNTY AIRPORT SCOTIA, NEW YORK

June 1989

Hazardous Materials Technical Center
The Dynamac Building
11140 Rockville Pike
Rockville, Maryland 20852

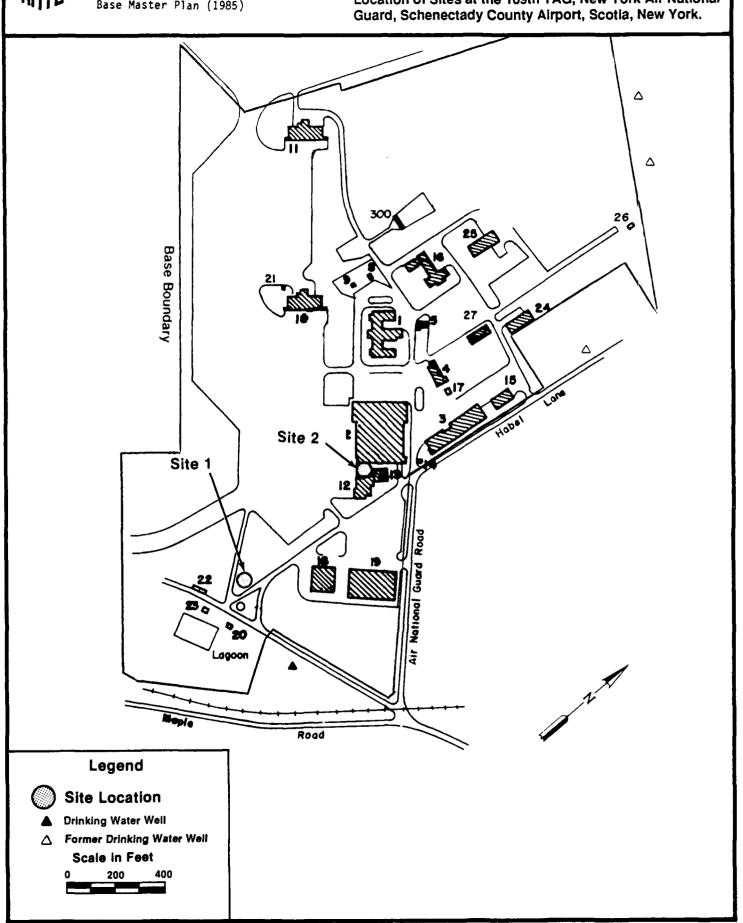
Figure 9.
Location of Sites at the 109th TAG, New York Air National Guard, Schenectady County Airport, Scotia, New York.

At the time of the site visit, no visible signs of contamination were observed at the FTA site. This site was scored on the basis of a "moderate" quantity release (between 1,000 and 5,000 gallons) of aviation gasoline and JP-4 jet fuel; these fuels are both ignitable (flashpoint less than 80°F) and toxic (Sax's level 3).

- At the time of the site visit, two empty 55-gallon drums and an empty 250-gallon container were observed in a ravine near the new POL construction site. The ravine is directly northwest of Building No. 25. The drums and container are so weathered that the former contents are unknown. Miscellaneous construction rubble is also in the ravine. No vegetative stress or other signs of contamination were observed in the ravine or in its immediate vicinity.

In accordance with applicable regulations, further IRP investigations are recommended for each of the identified sites.
